September 9, 2017

RE: EGRET
DOC: 262719
HULL#: NONE
TYPE: 1951 CHESAPEAKE DEADRISE SKIFF

SURVEY SUMMARY SECTION 1 OF 2

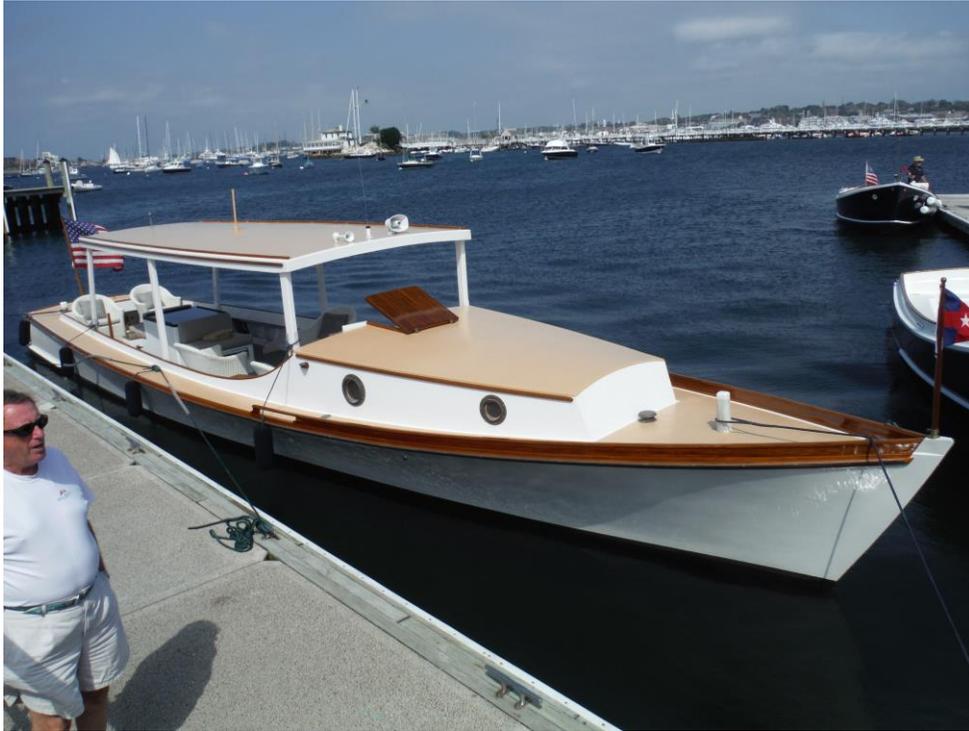
FORWARD VIEW OF THE VESSEL

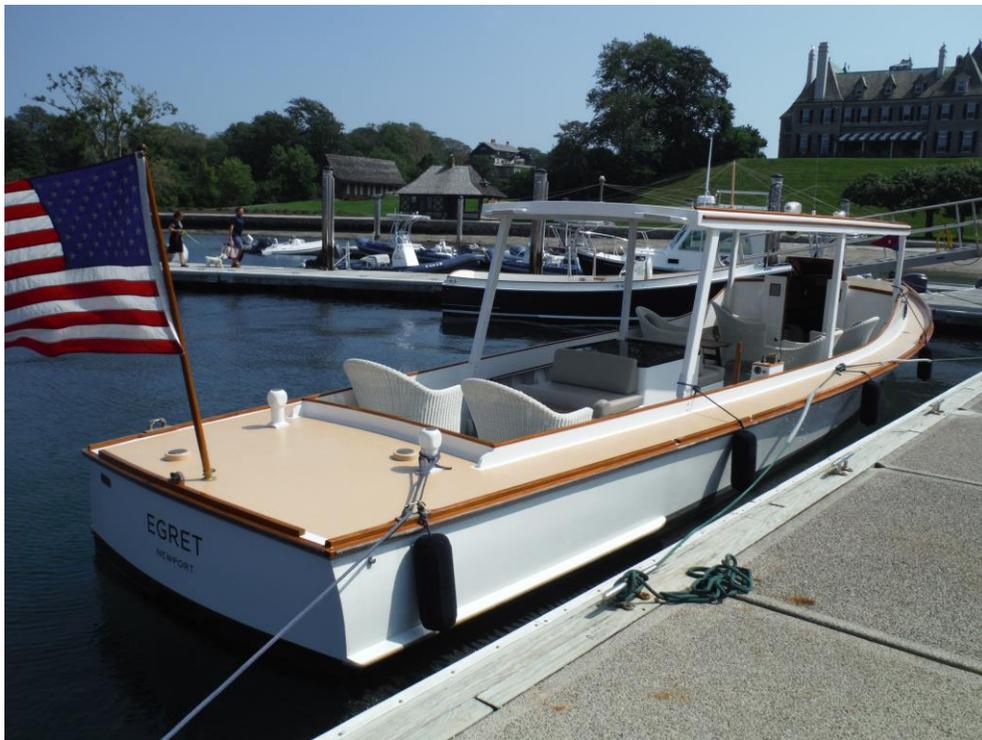
AFT VIEW OF THE VESSEL

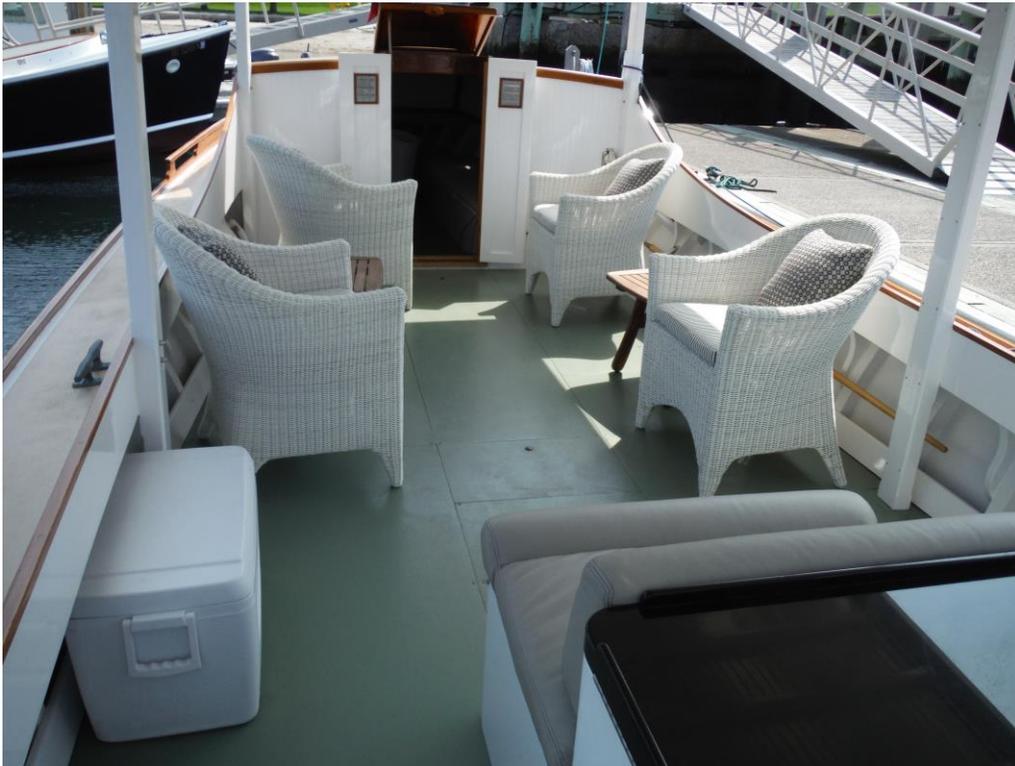
COCKPIT LOOKING FORWARD FROM THE ENGINE BOX

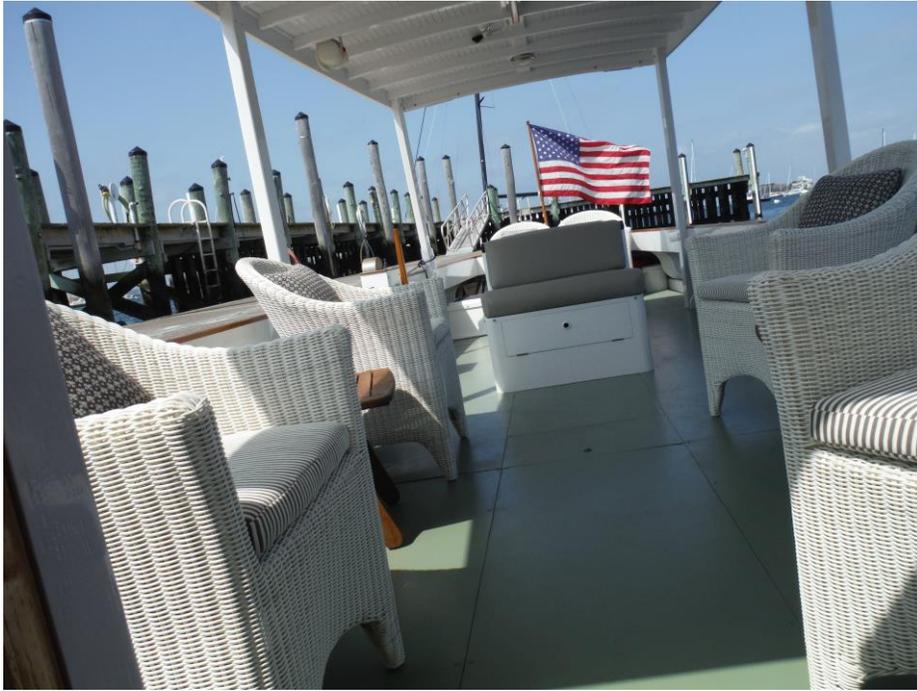
COCKPIT LOOKING AFT FROM THE CABIN

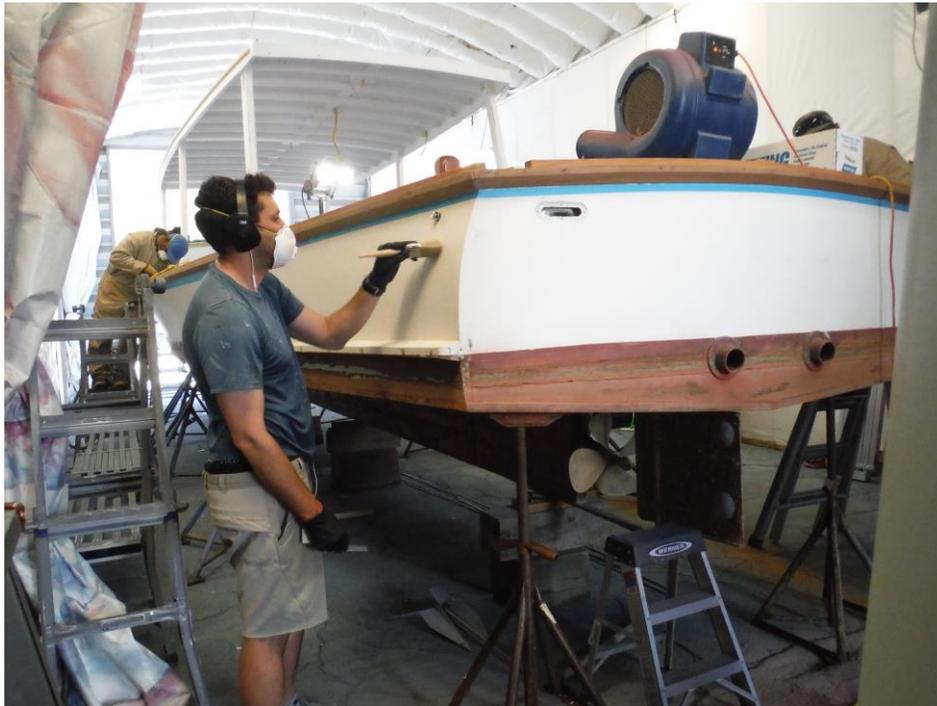
VESSEL AT YARD FOR FINAL PAINTING

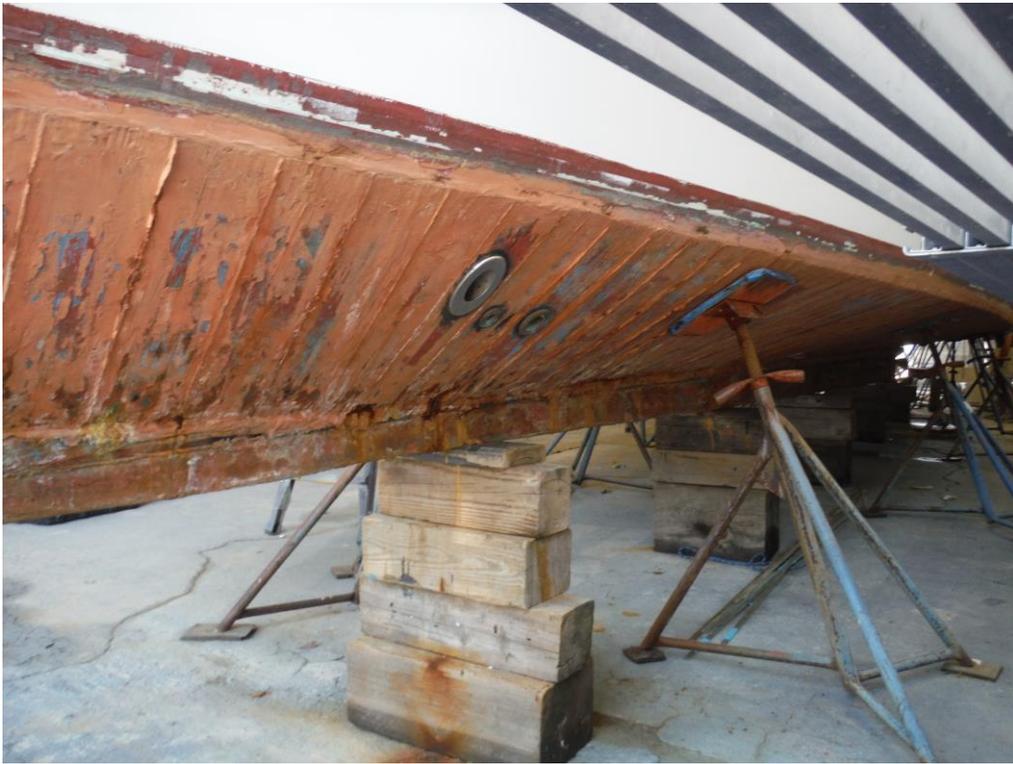
FORWARD VIEW OF THE BOTTOM – NOTE CROSS PLANKING

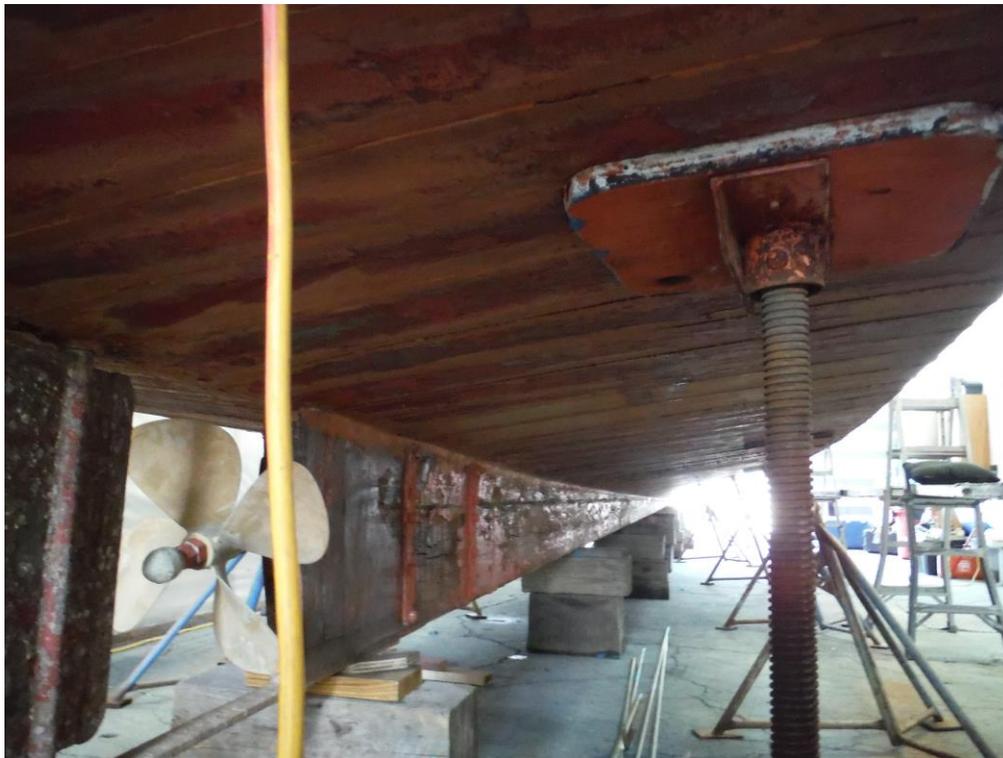
AFT VIEW OF THE BOTTOM

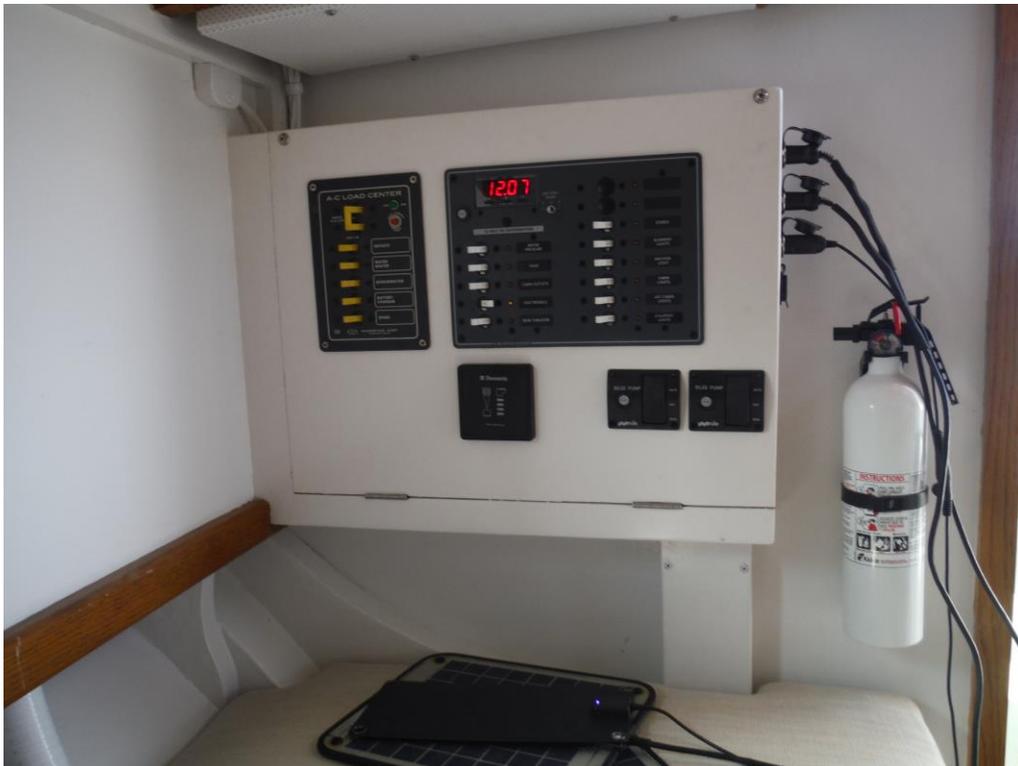
VIEW OF THE ELECTRICAL PANEL

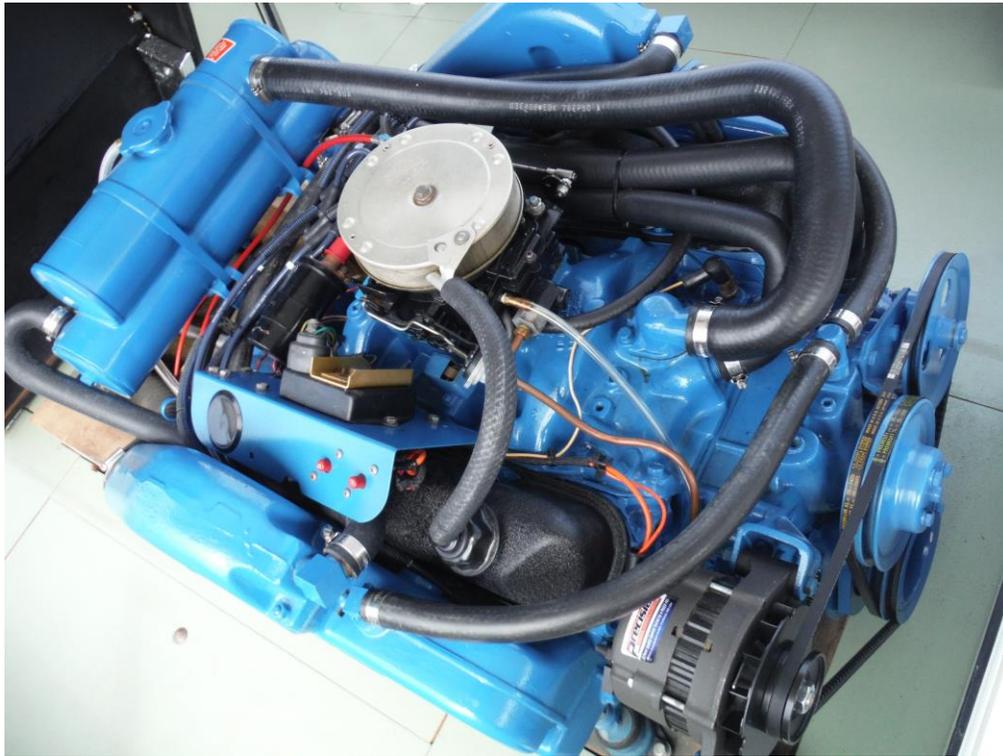
VIEW OF THE REBUILT ENGINE

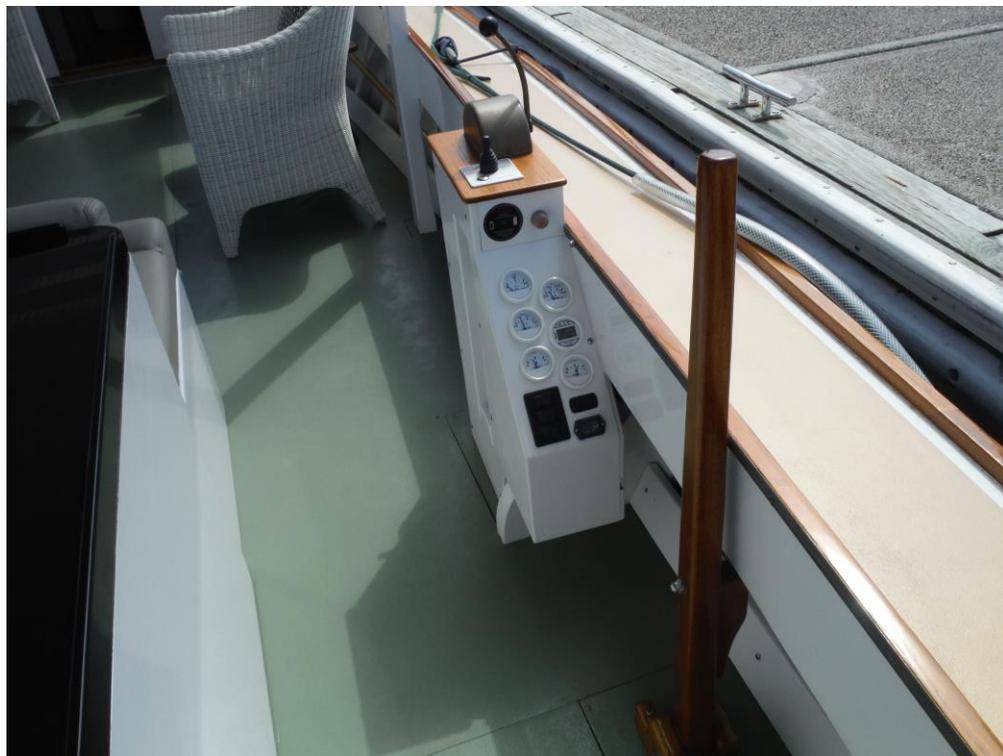
VIEW OF THE HELM AND NEW ENGINE INSTRUMENTS

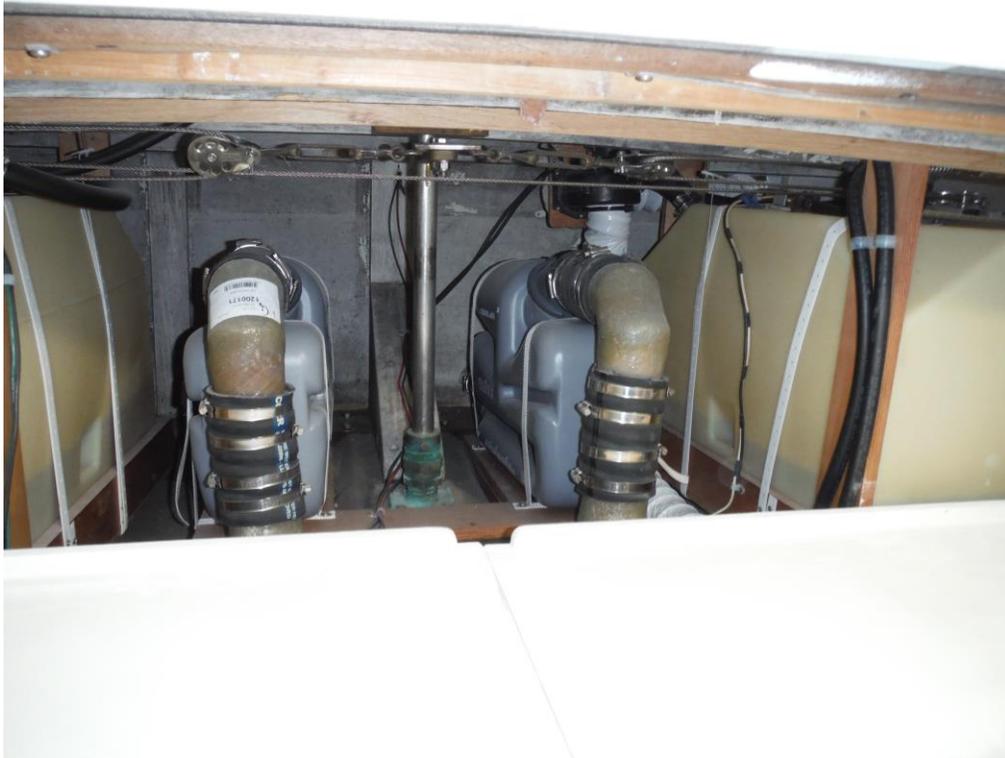
VIEW OF THE EXHAUST AND THE NEW FUEL TANKS

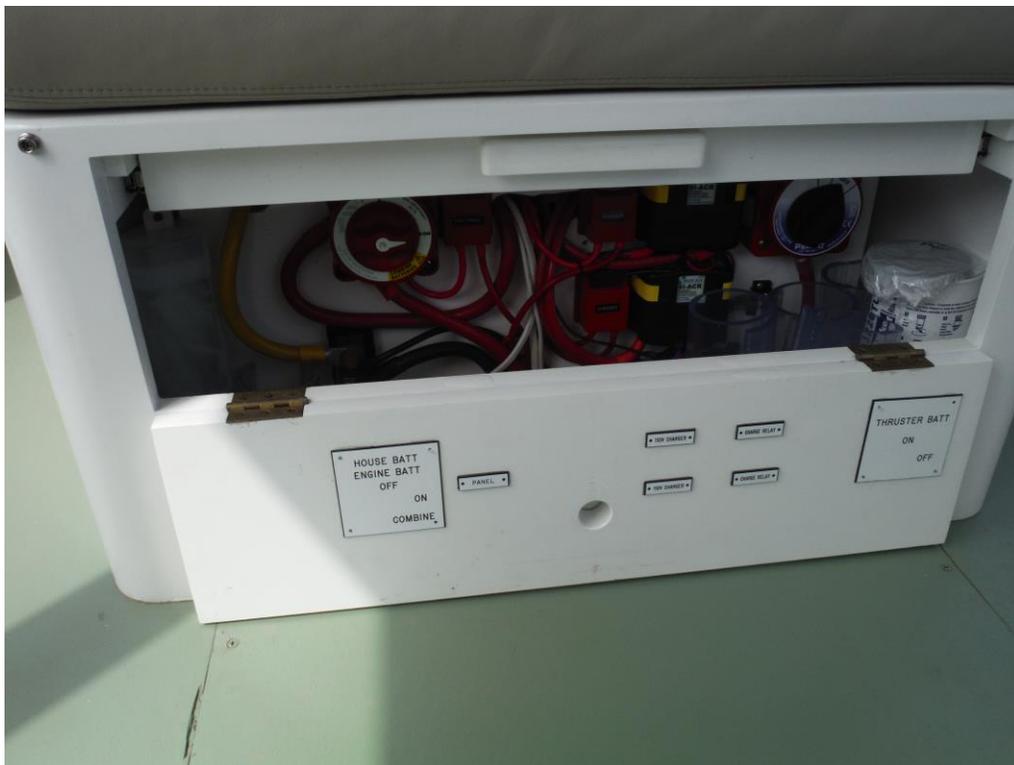
VIEW OF BATTERY SWITCHES

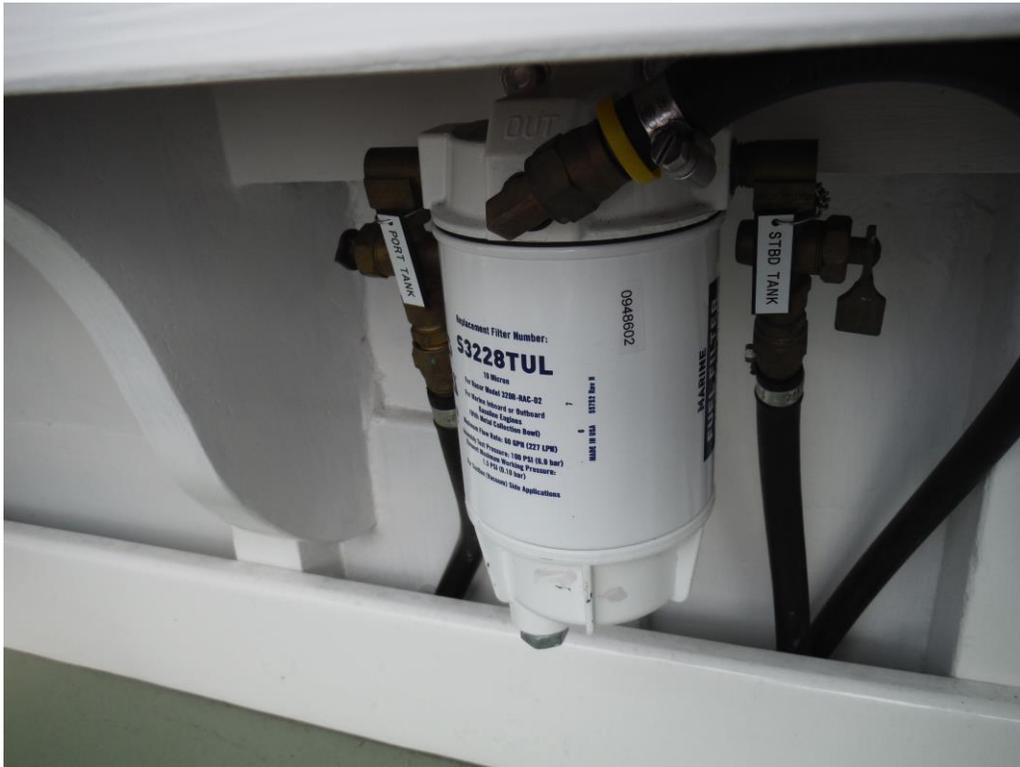
VIEW OF THE FUEL SYSTEM

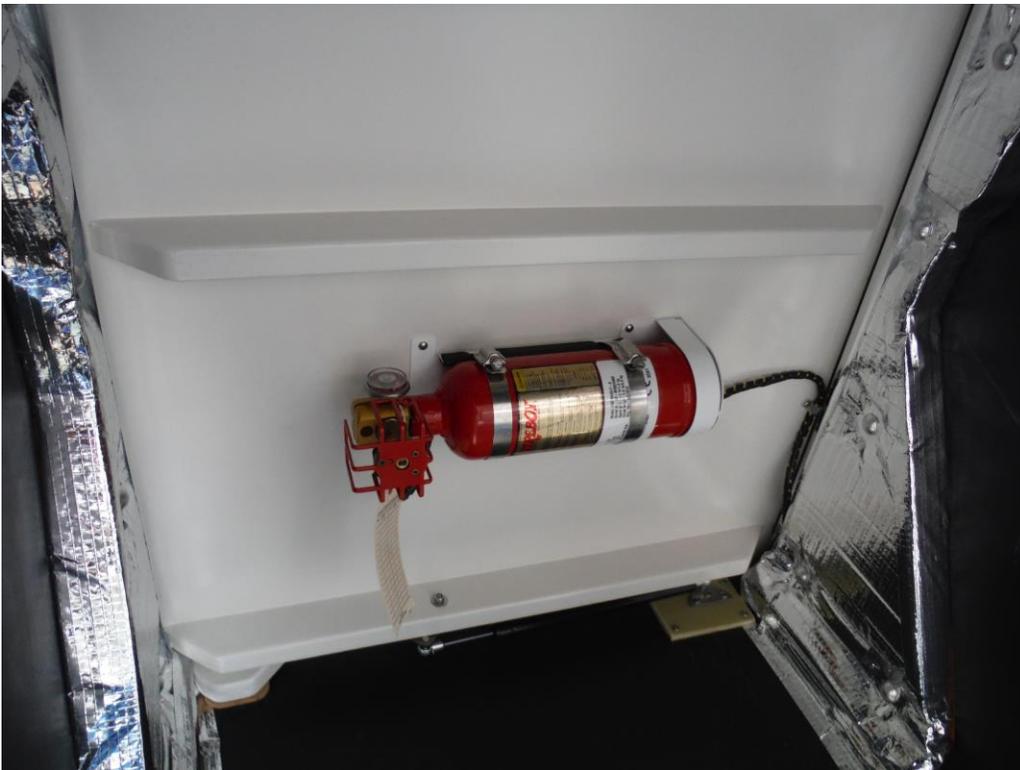
AUTO FIRE EXTINGUISHER

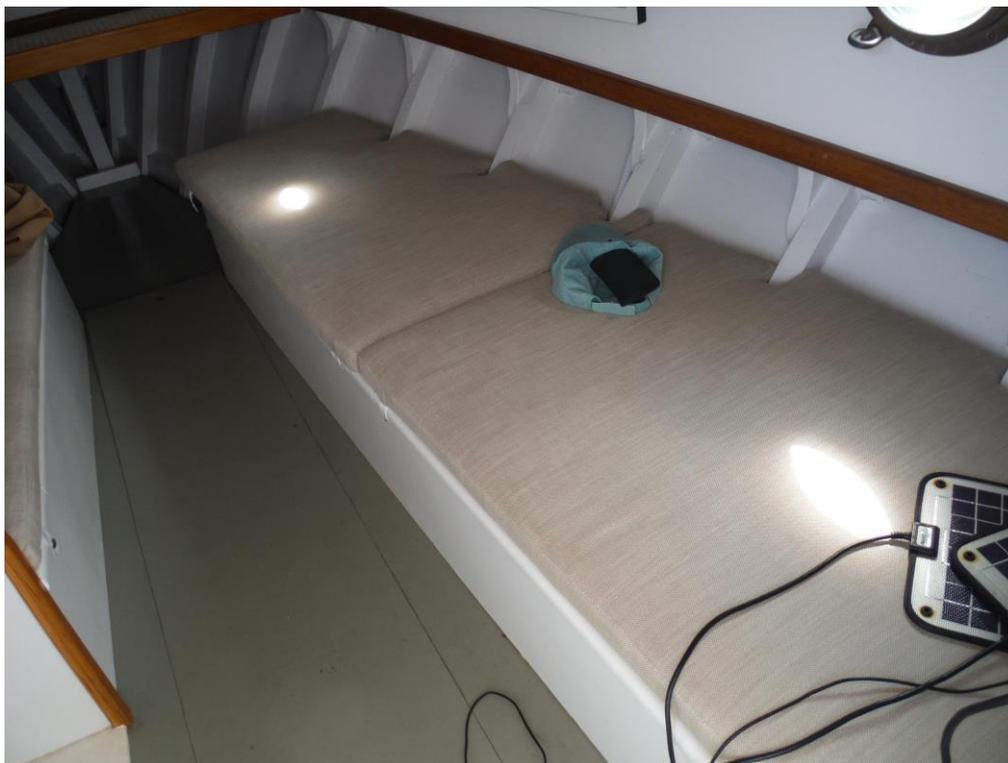
CABIN FORWARD TO STARBOARD

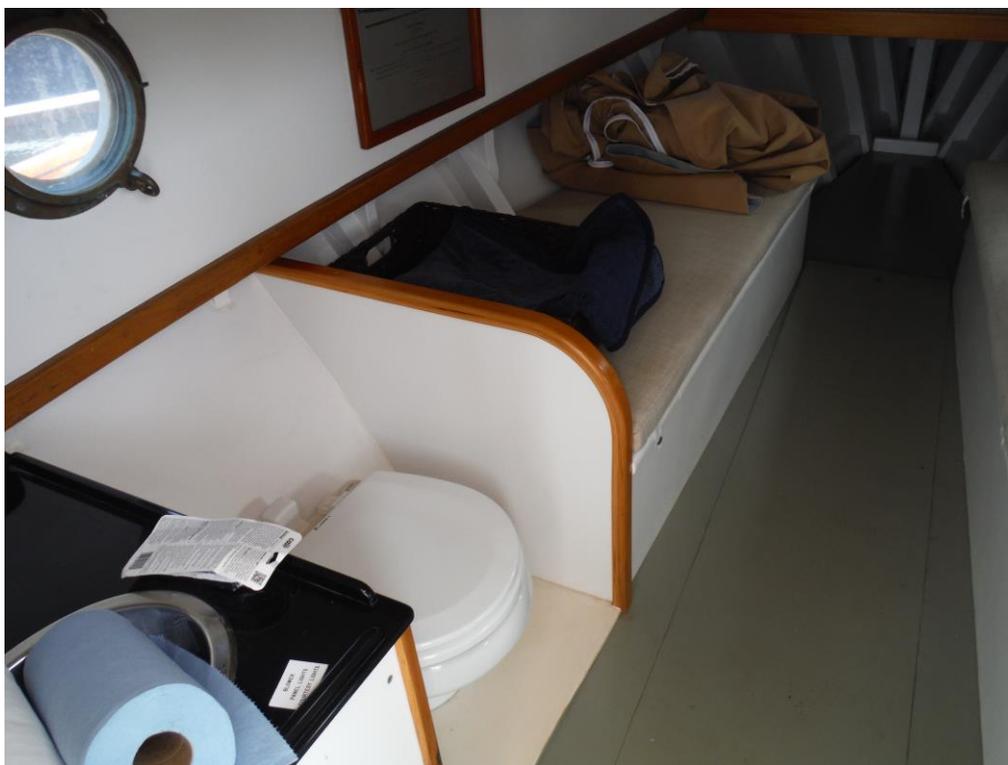
CABIN FORWARD TO PORT

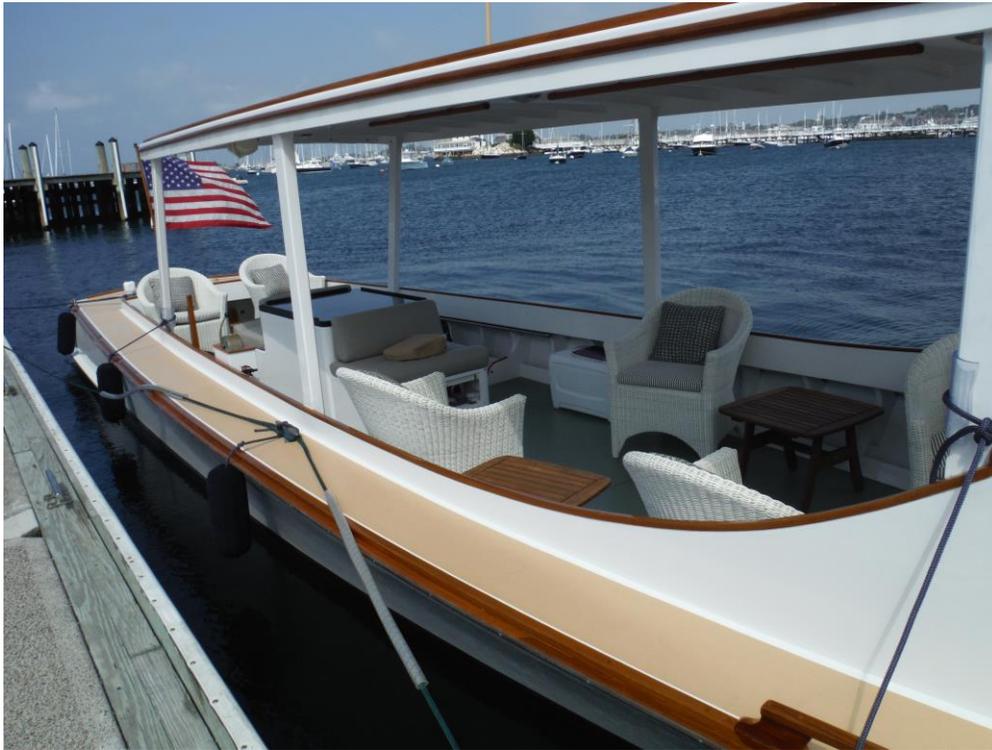
VIEW OF THE COCKPIT SET UP WITH CHAIRS
